OPERATING EXPERIENCE WEEKLY SUMMARY

Office of Nuclear and Facility Safety

May 1 - May 7, 1998

Summary 98-18

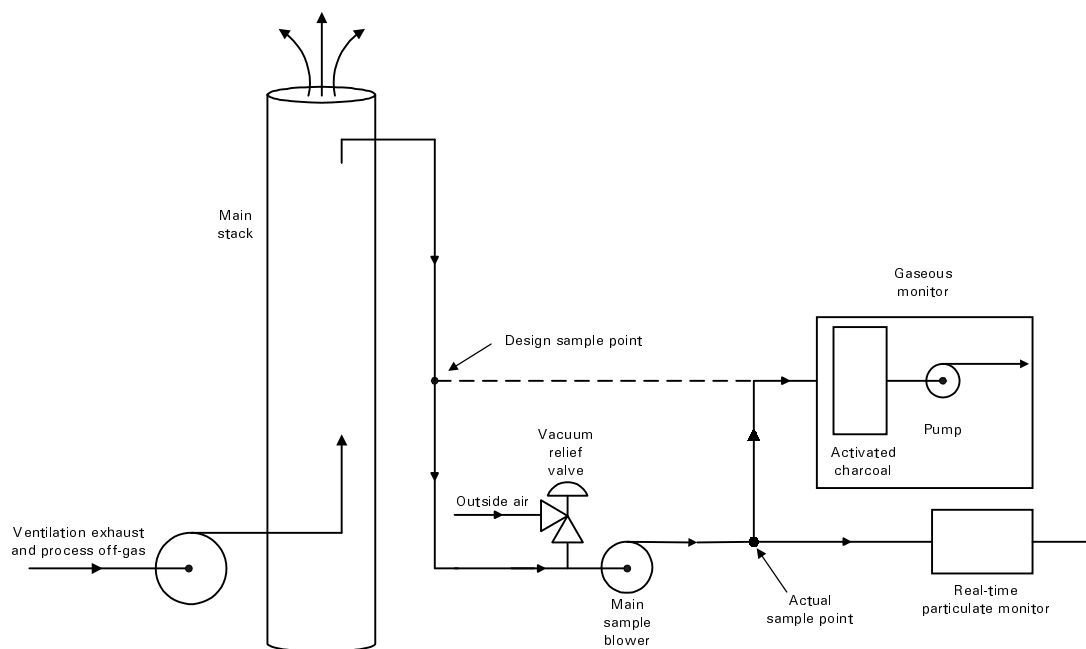
Figure 2-1. Simplified Schematic of Stack Monitoring System

On March 11, 1998, at the Idaho Chemical Processing Plant, facility personnel discovered that data from a main stack gaseous monitor was in error because monitor installers changed a sample point specified in the original design to one downstream of a vacuum relief valve designed to add atmospheric air to the stack sample flow. The original design sample point was on the suction side of the sample blower, upstream of the relief valve. Because the gaseous monitor pump was not strong enough to draw an adequate flow from this low-pressure point, monitor installers changed the sample point to the higher-pressure discharge side of the sample blower. However, they did not use existing site configuration control requirements when they changed the sample point. Facility personnel corrected release values and determined that they never exceeded release limits during operation of the stack with the gaseous monitor sample point in the wrong position. Inadequate configuration control could have resulted in an inability to detect excessive stack radiological emissions. (ORPS Report ID-LITC-WASTEMNGT-1998-0002)

The gaseous monitor monitors the stack release of iodine-129 and tritium to the atmosphere. The monitor draws a sample of stack effluent through activated charcoal, which adsorbs gaseous radionuclides. Personnel remove the activated charcoal periodically and analyze it for radionuclide content. Investigators determined that the location of the sample point resulted in the monitor indicating approximately one-half of the actual stack radiological emissions because air introduced by the vacuum relief valve diluted the sample stream. The relief valve bleeds in atmospheric air to provide enough airflow to keep the sample blower from overheating. They also determined that, because the monitor had never indicated more than one-sixth of the allowable stack radiological emissions, the actual emissions never exceeded one-third of the allowable emissions. Figure 2-1 shows a simplified schematic of the stack monitoring system.

The facility manager determined that the root cause of this event was that installers did not follow site configuration control requirements when they discovered that the original design of the monitor installation was inadequate. Corrective actions included using site configuration control requirements to select an appropriate sample point that meets the sampling requirements, plumbing the sampler to this location, testing the sampler for proper operation, and documenting all activities related to the design change.
